Manhole Inspection Summary

Manhole # S49GG_045MH

Insp Date: **8/8/08 11:22 AM**

Location Address: **Grogan**

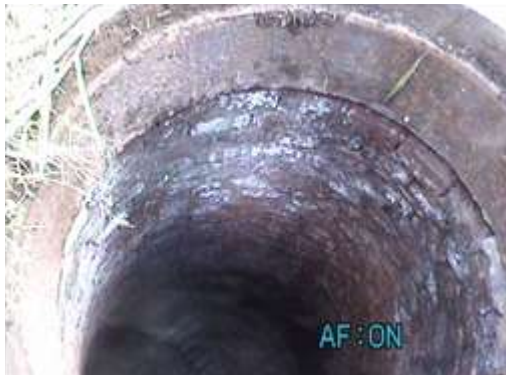
Defect 2

Frame Offset: **0.5** (in.) Condition: ☒ Sound ☐ Cracked ☐ Leaks

frame leaks

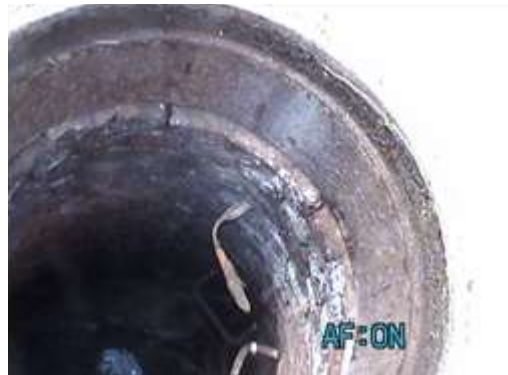
Defect 1

Condition: ☐ Sound ☐ Cracked ☐ Root Intrusion ☒ **Loose Brick** ☐ Deteriorated

Infiltration: ☐ None ☐ Joint ☐ Cracks ☒ **Mortar** ☐ Roots ☐ Wall

Infiltration

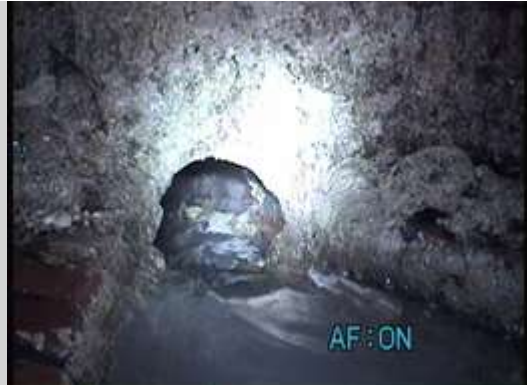
12 O'Clock Outflow

8 in. Circular Gravity Sewer
Pipe Out @ 12 O'Clock

Pipe Height: **8.4** (in.) Rod and Bar (Angled)
Pipe Material: **Clay** ☐ Pipe Lined
Invert Depth: **12.00** (ft.) Flow Characteristics: **Fast**
Deposits: ☒ None ☐ Mud ☐ Sludge ☐ Debris ☐ Grease
Silt Depth: (in.) Deposits Extent:
Infiltration: **None** Pipe Seal Cond: **Sound**

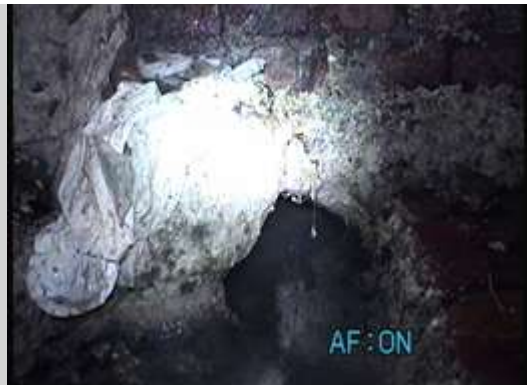
3 O'Clock Inflow

8 in. Circular Gravity Sewer
Pipe In @ 3 O'Clock

Pipe Height: **8.4** (in.) Rod and Bar (Angled)
Pipe Material: **Clay** ☐ Pipe Lined
Invert Depth: **11.95** (ft.) Flow Characteristics: **Fast**
Deposits: ☒ None ☐ Mud ☐ Sludge ☐ Debris ☐ Grease
Silt Depth: (in.) Deposits Extent:
Infiltration: **None** Pipe Seal Cond: **Sound**

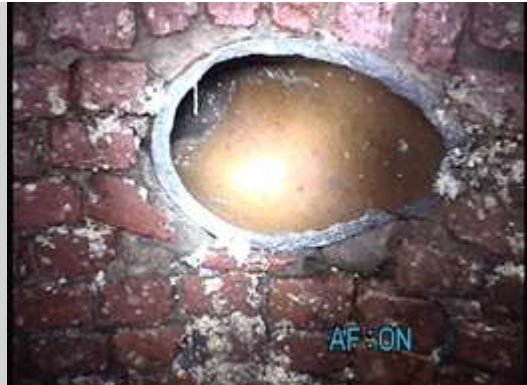
7 O'Clock Inflow

Pipe In @ 7 O'Clock

Infiltration: **None** Pipe Seal Cond: **Sound**

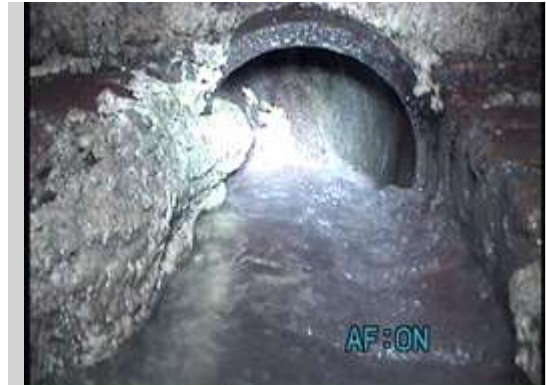
Drop In @ 7 O'Clock

Drop: Inside	Rod and Bar
Angled: Yes	Reading: 10.90 (ft.)
	Inv Depth: 11.90 (ft.)
Drop Condition: Open
